Maryland Historical Trust
State Historic Sites Inventory Form

Survey No. WO-134

historic ~~Scott House~~ John A. Purnell House

street & number 204 South Main Street ___ not for publication

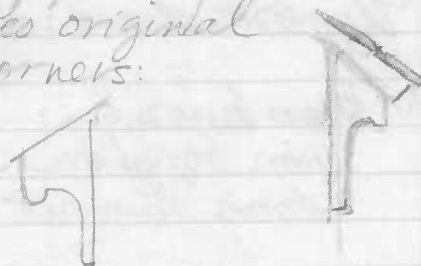
Equally notable out house:

Gable roof, new wooden shingles

Siding hand riven shingles over wide horizontal boards.

Interior seats removed; exposed rafters, framing and walls whitewashed

Door is later replacement

Gable end window opening facing east is louvered

South west corner features original

Replacements in other corners:
